INFRARED GUYS, Inc.

Sample report pages from an Electrical Inspection of an office building in downtown Atlanta.

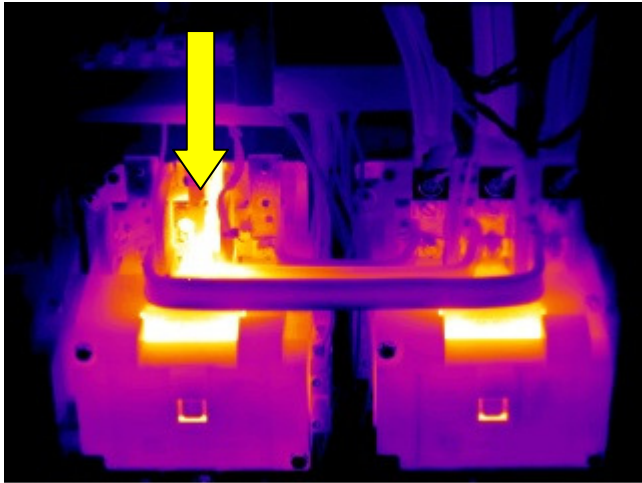
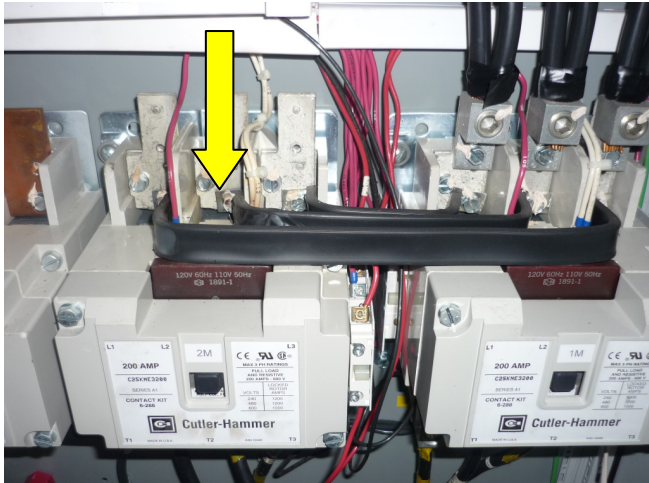
Anomaly Data							
Location		Equipment		Fault Location		Line/Load	Phase/Top/Right
7 th Floor		Carrier Control Cab		Lug		Load	B Phase
Temperature			Amperage			Ambient	Delta T
A/Top/Left	B/Center	C/Bottom/Right	A/Top/Left	B/Center	C/Bottom/Right	76	126
130	256	130	88	86	90		
Anomaly No.	Probable Cause		Recommendation			Classification	
3	Poor Connection		Verify, Clean, Tighten			Critical	
Field Observation							
Discoloration on lug from overheating.
